# The “Placida Bunk House”

Charlotte County Parks, Recreation  
and Cultural Resources

Final Report

September 2008

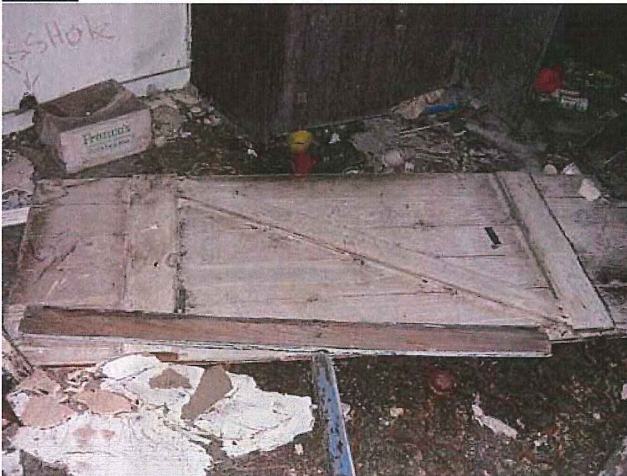
Door found inside building

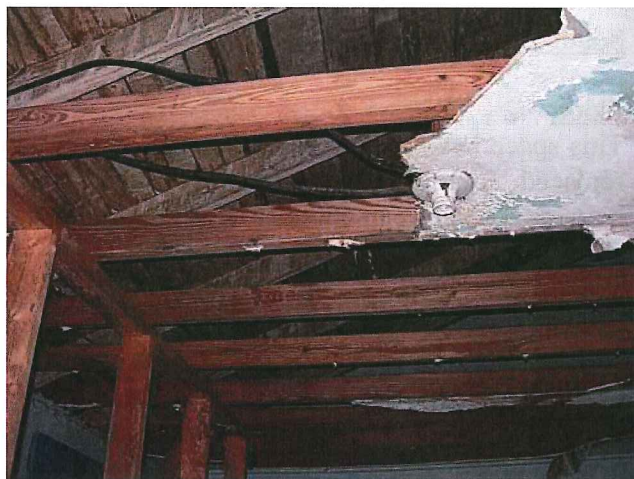
Ceiling framing and roof rafters

Condition: The rafters are in good condition on the interior, but some exterior rafter ends exhibit significant decay.

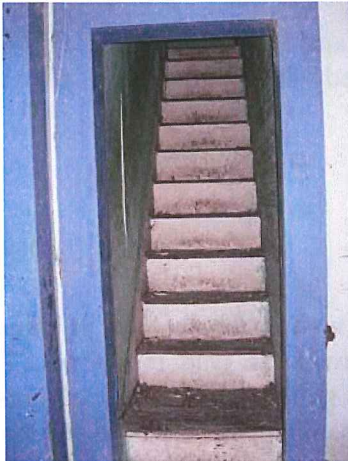
The stair opening has wood casings, and a small landing is located at two risers above the first floor level. An opening was located on the west side onto this landing in the 1940s, this has been enclosed with gypsum wallboard. The east wall is clad with heart pine beaded board.

View up the stairs

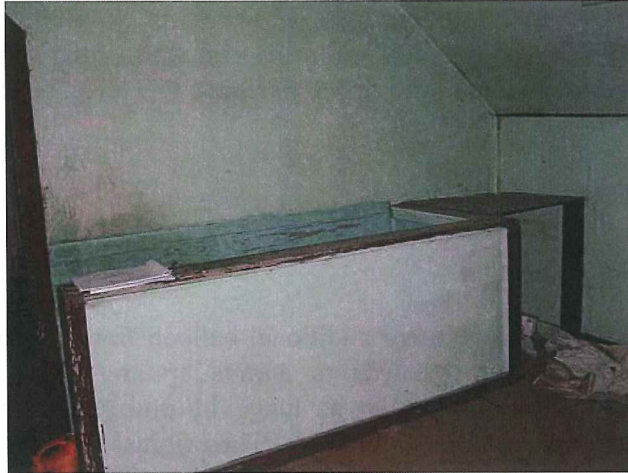
Knee wall at top of stairs

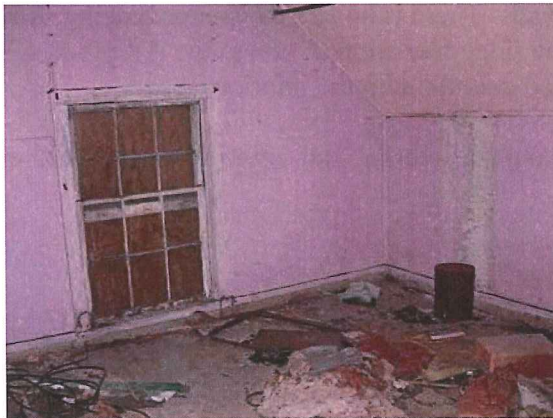
East room of Loft

This space has wood flooring in fair condition.

The walls and ceiling are covered with a thin layer of plywood, that is painted. This material was added after the mid 1950s. The material is in poor condition.

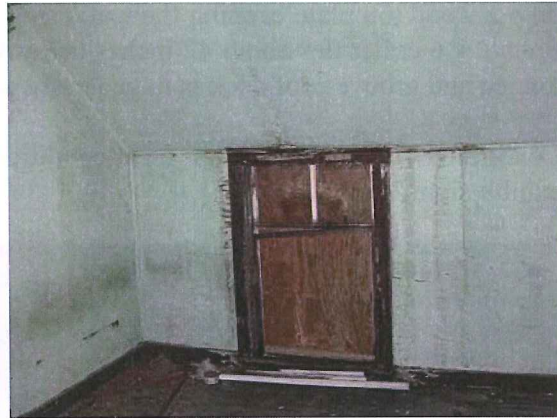
West room of Loft
